Ice/Frost/Debris Assessment For Space Shuttle Mission STS-32 (61-C)

January 20, 1986

Charles G. Stevenson
Gregory N. Katnik
The John F. Kennedy Space Center, NASA
and Robert F. Speece
Lockheed Space Operations Company
Kennedy Space Center, Florida

ICE/FROST/DEBRIS ASSESSMENT
FOR
STS-32 (61-C)
LAUNCHED
JANUARY 12, 1986

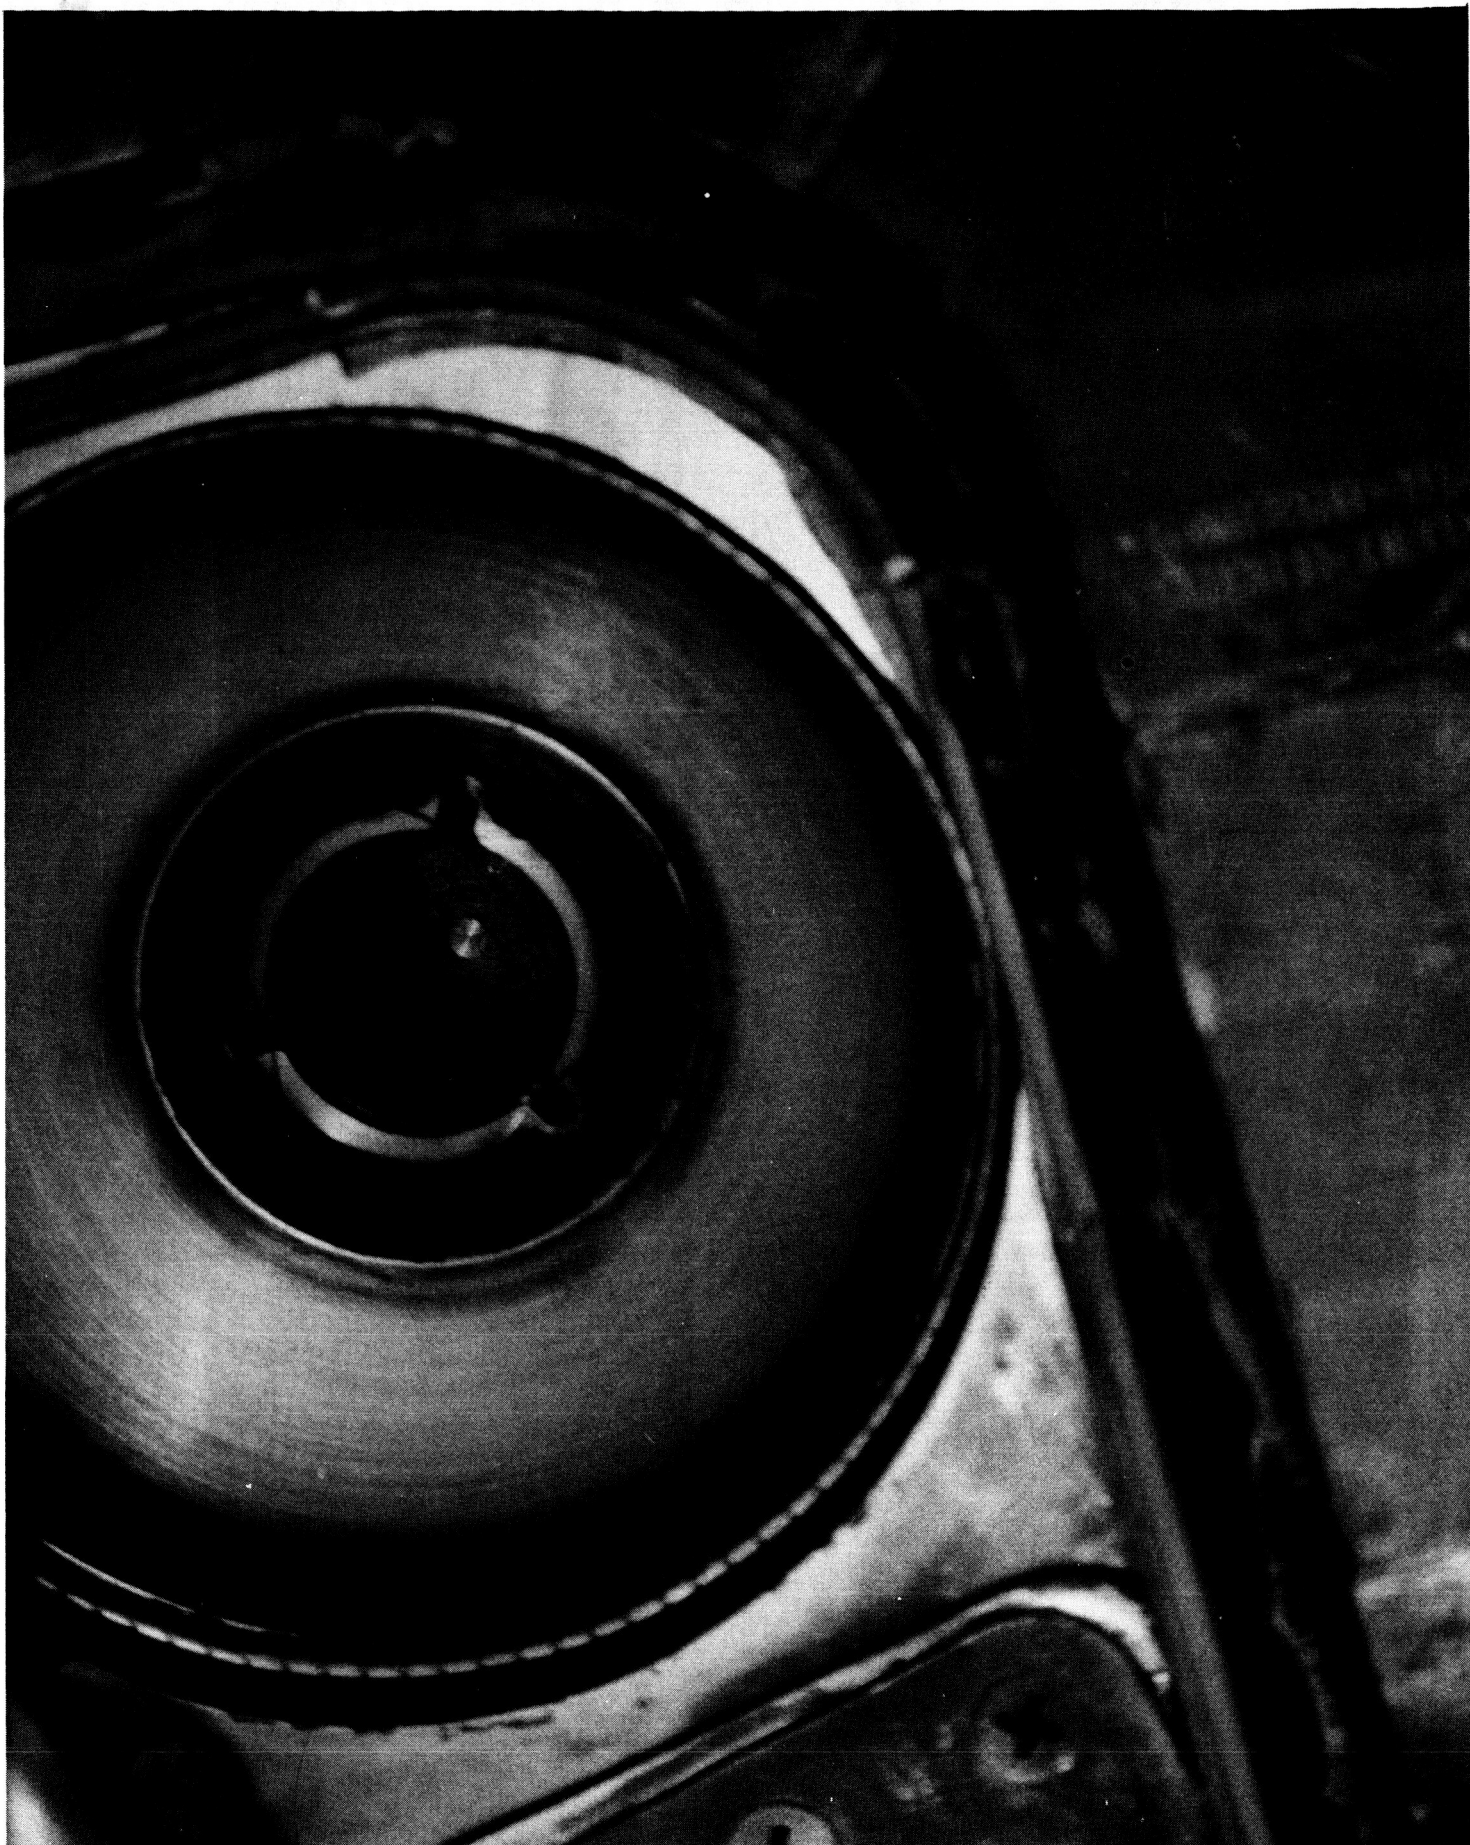
NSI fragments in Separation Bolt hole

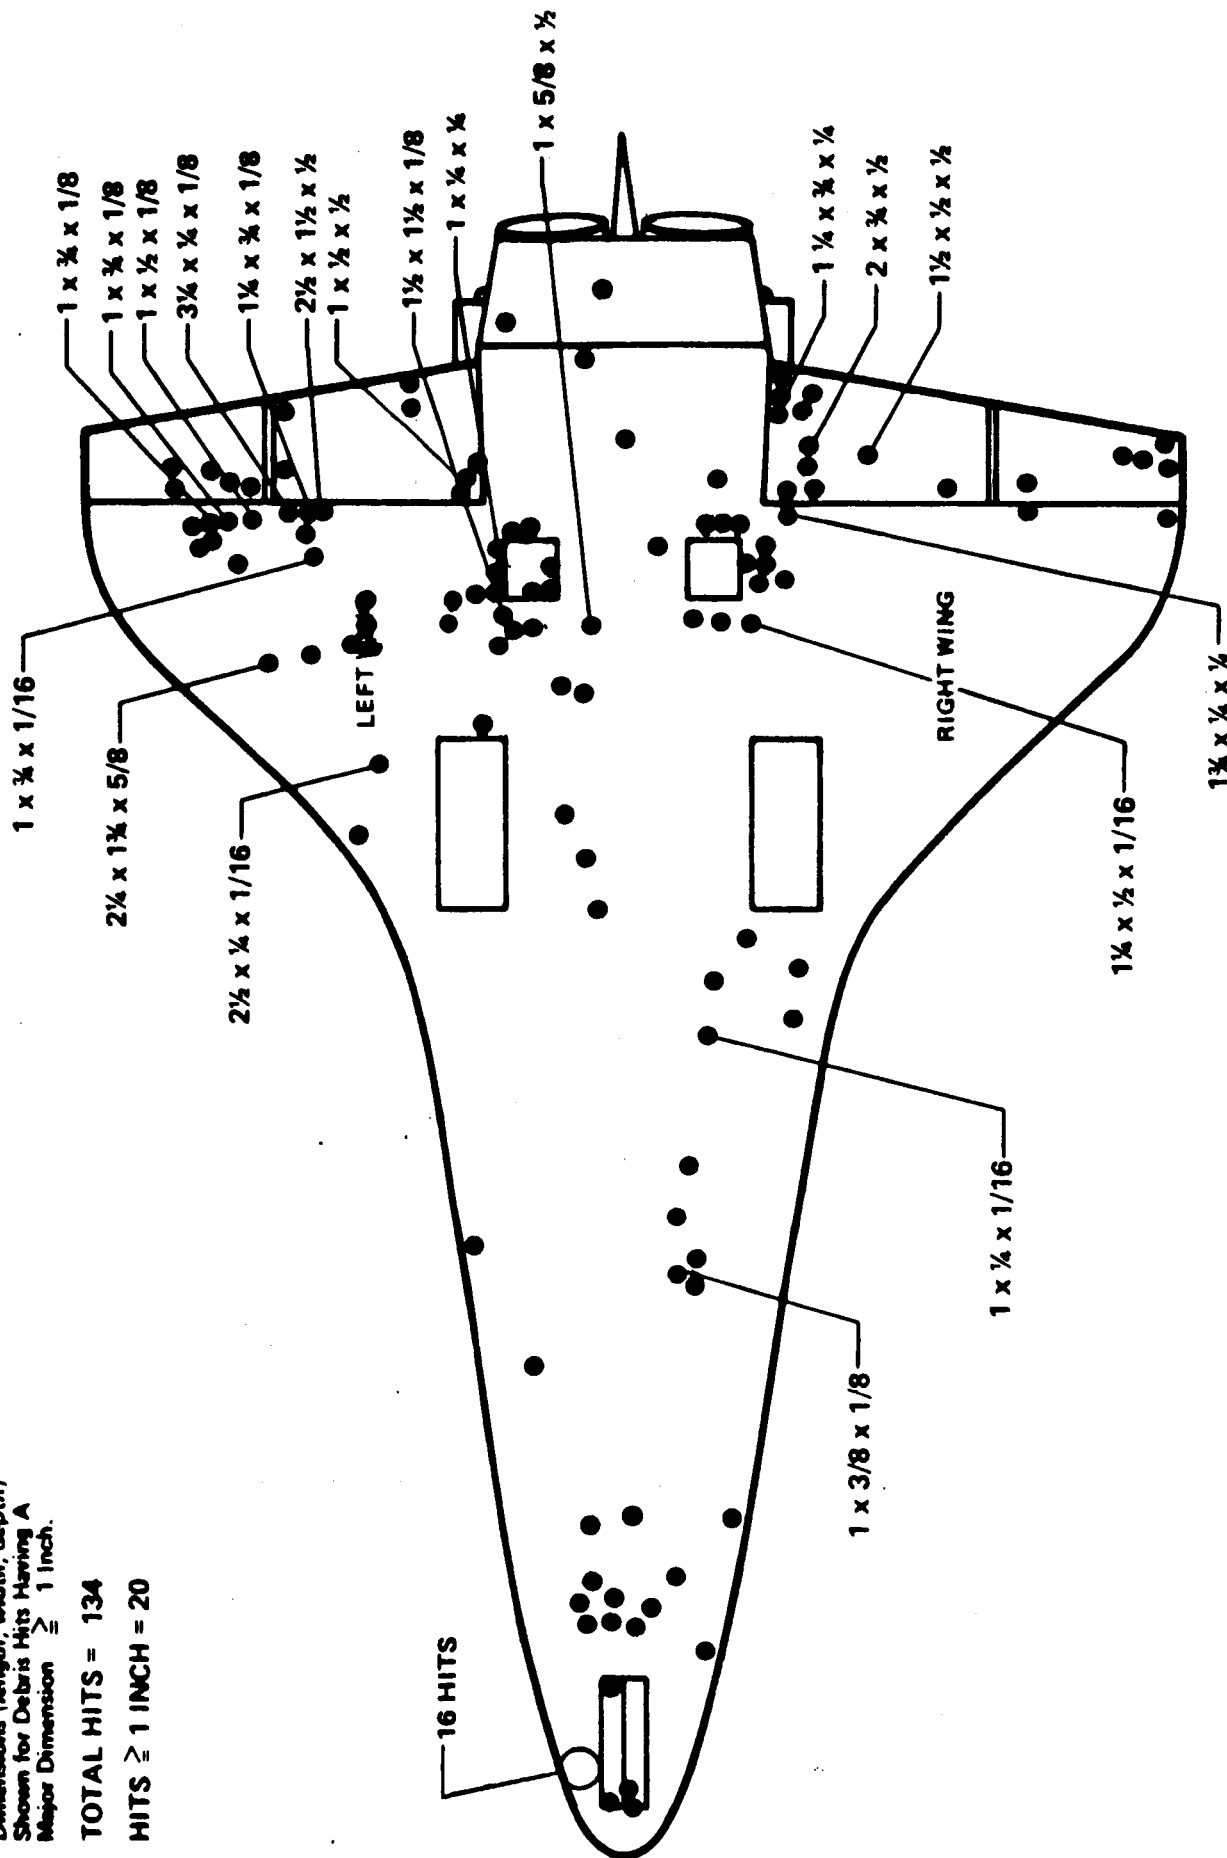
MISSION - STS 32 (61C)
 DEBRIS DAMAGE MAP
 RIGHT SIDE

TOTAL HITS = 134

HITS ≥ 1 INCH = 20

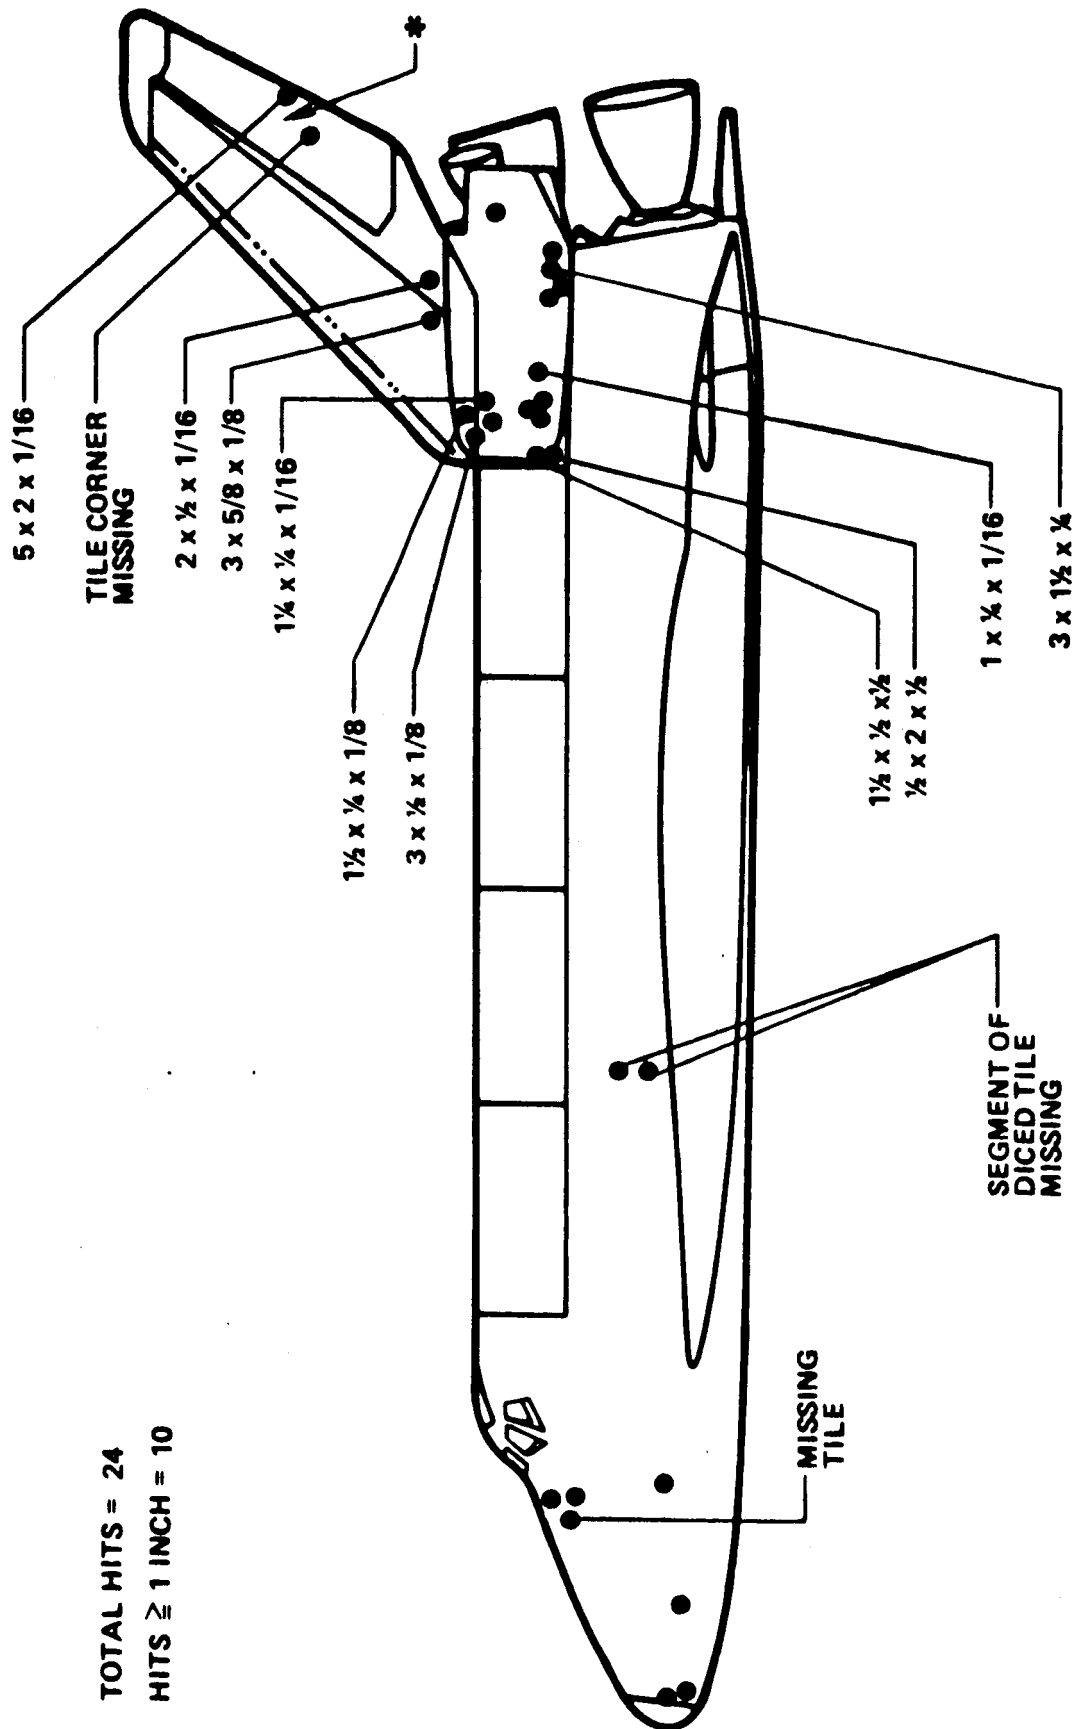
TOTAL HITS = 24
HITS \geq 1 INCH = 10

*12" LONG METAL SEAL LOOSE AND FALLING OUT
LOCATED ON INSIDE SURFACE OF LEFT SPEED BRAKE
